Colorado Division of Reclamation, Mining & Safety

Project Summary

Gold King Bond Forfeiture M-1986-013

Phase I 2008 Permanent Portal Discharge Diversion Structure

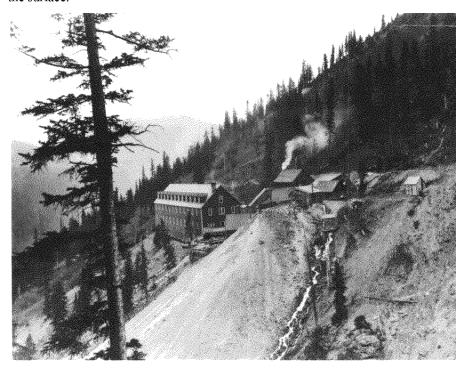
Historic Gold King Mine photo

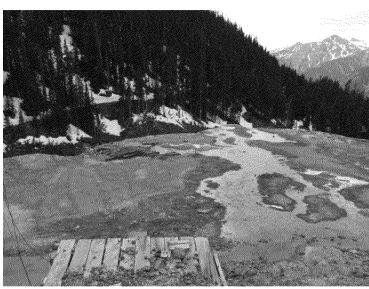
During the summer of 2007 the mine drainage from the Level 7 portal breached the existing ditch and saturated the top of the Level 7 mine waste pile. The saturated conditions of the waste pile lead to a slope failure that partially blocked access to the site and filled the North Fork of Cement Creek and the associated culvert under the access road with mine waste. The landowner of the site, Todd Hennis, re-installed the culvert and removed the mine waste from the access road, but did not completely address the breached ditch.

2007 Saturated Mine Waste and breached ditch

In 2008, DRMS took action and halted the saturation of the Level 7 mine waste pile. DRMS met with Todd Hennis, landowner, and settled on moving the ditch to an eastward flowing direction and lining the ditch with half round HDPE pipe. The location of the ditch is ideal for both long term closure of the site and any future mining activity.

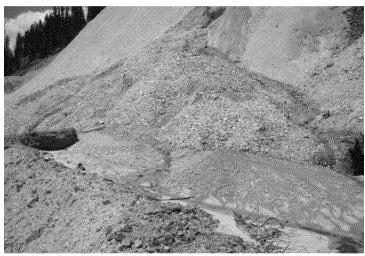
2007 Slope Failure

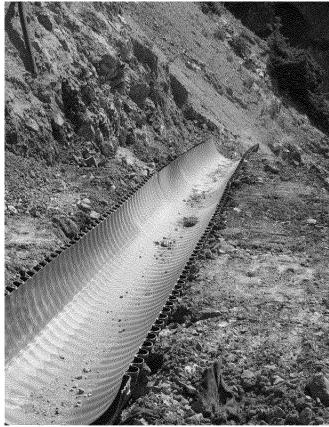
$2008-Installation\ of\ permanent\ portal\ discharge\ diversion\ structure$

The project was constructed during the week of August 25, 2008. The new permanent portal discharge diversion structure was excavated into the top of the mine waste and 165 foot of half round 36" diameter corrugated pipe was set at a 2-3% grade.
